# Manhole Inspection Summary

Manhole # S13AA2001MH

**Location** Address: **5613 SULGRAVE AVE**

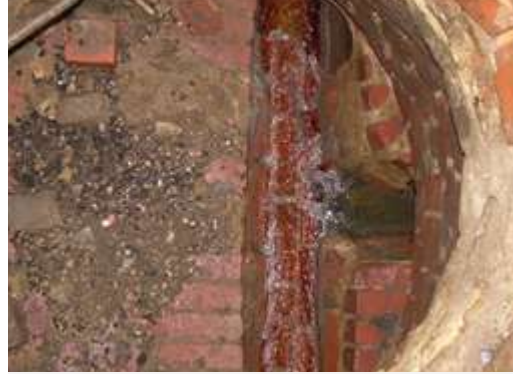
Top View

Evidence of surcharge - Bench debris.

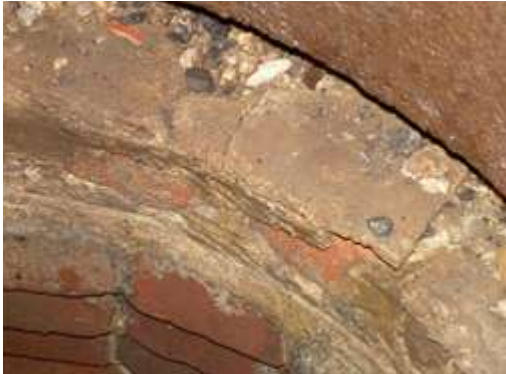
Defect

Frame leaks. Frame offset. Adjustment deterioration and infiltration.

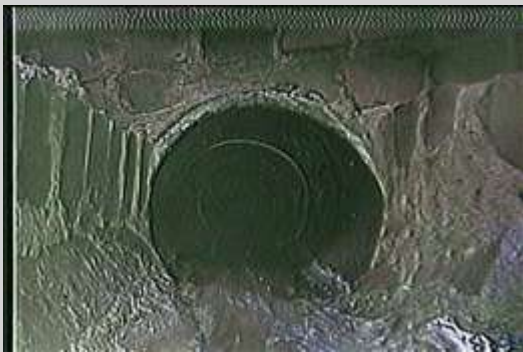
### 10 in. Circular Gravity Sewer Pipe Out @ 12 O'Clock

Infiltration: **Evidence** Pipe Seal Cond: **Cracked**

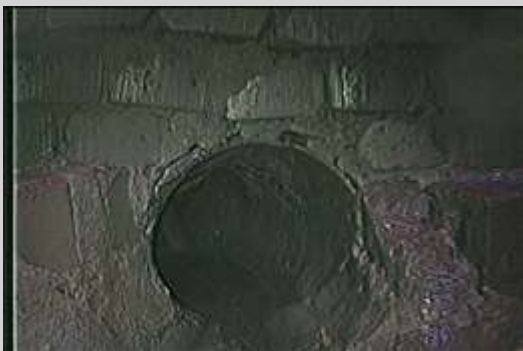
### 8 in. Circular Gravity Sewer Pipe In @ 3 O'Clock

Infiltration: **Evidence** Pipe Seal Cond: **Cracked**

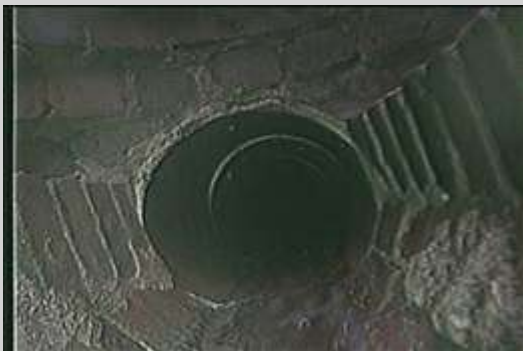
10 in. Circular Gravity Sewer  
Pipe In @ 6 O'Clock

Barrel deterioration and infiltration. Channel root intrusion.

Infiltration: **Evidence** Pipe Seal Cond: **Cracked**
